Excavation for Establishing an Archaeological Experiential Museum at Vadnagar: Challenges Encountered and Strategic Solutions

Heritage: Journal of Multidisciplinary Studies in Archaeology 12 (2024): 1372-1388

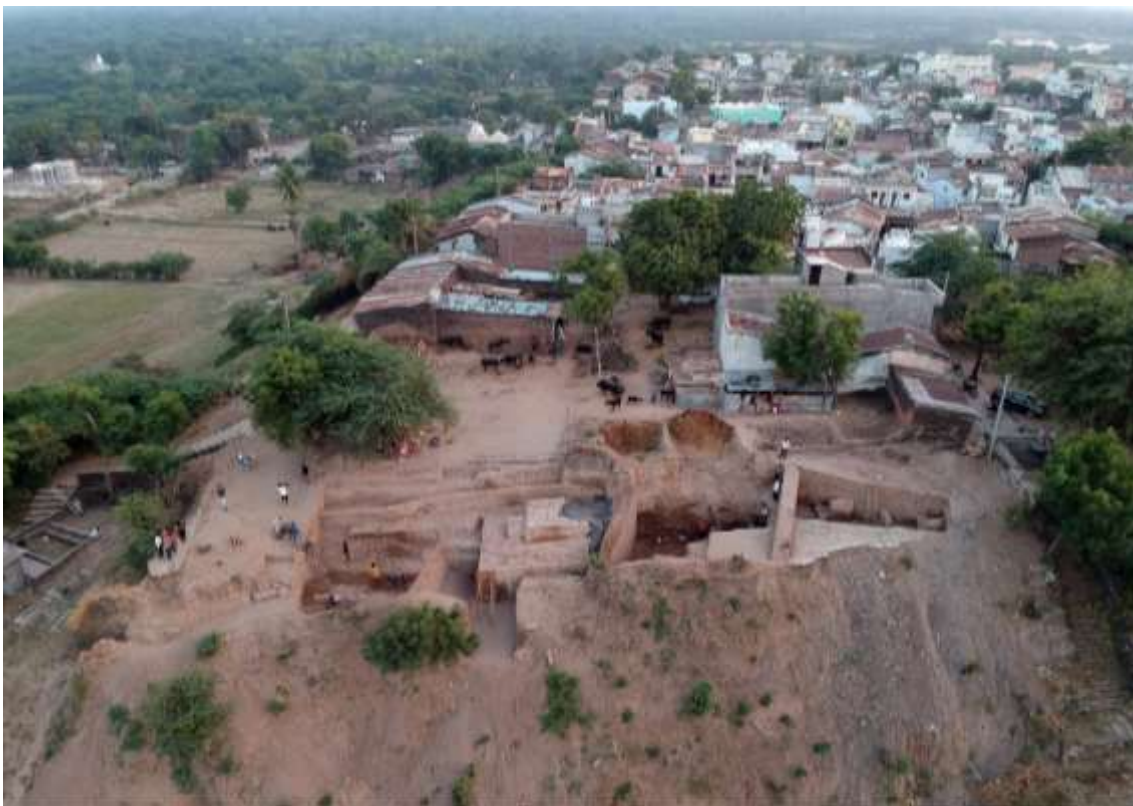
Figure 1: Demarcated area for setting up Archaeological Experiential Museum, North-eastern periphery of the town

wherein visitors would be provided with an experience of archaeological remains through touch-and-feel medium. It was also proposed that an elevator would be designed for allowing visitors into the deep excavated trenches of around 20m. Consequently, a time schedule had been prepared in which the responsibility assigned to ASI was the excavation of 4000m² area, while the infrastructure development would be undertaken by the Govt. of Gujarat. For this exceptional project, 4 acres of land had been decided on for acquisition (out of which only 1 acre had been short-listed to be excavated and the rest to be utilized for infrastructure and allied activities), which is located on south-eastern bank of Sharmistha Lake (north-eastern corner of the town) (Figure 1).

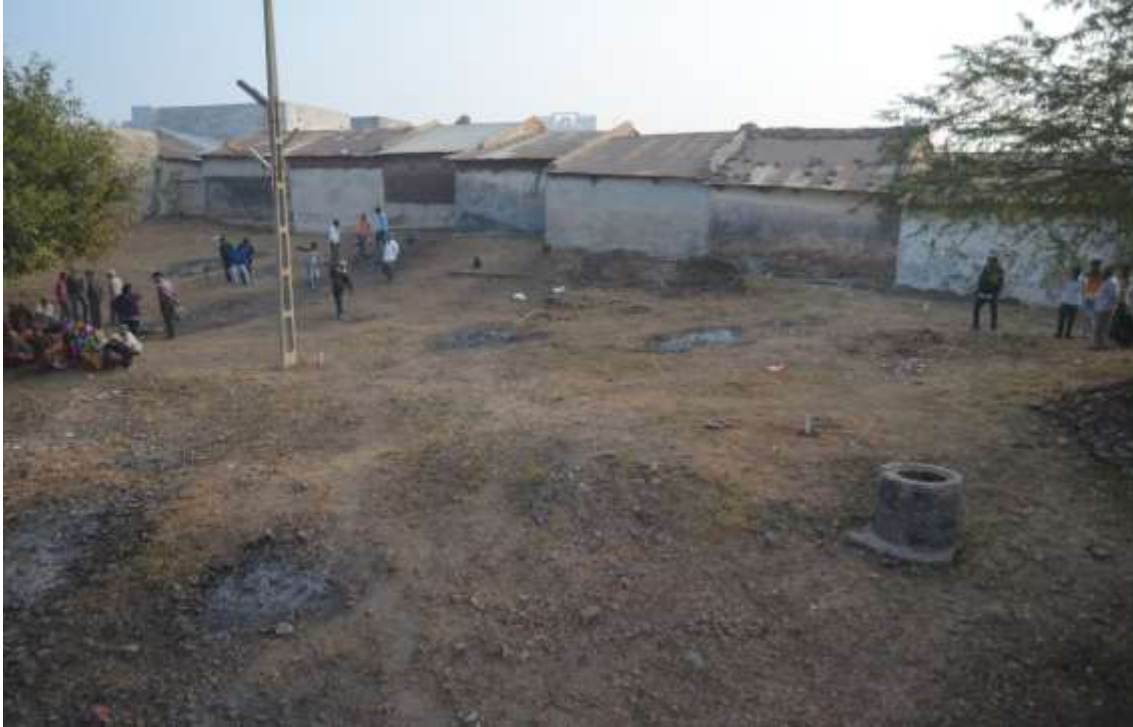
Figure 2: Preparation for laying out excavation trenches

As the time schedule framed for completion of the excavation work was within 600 days by the ASI, accordingly 24 grids of 10x10m were planned for the field season 2019 onwards. Following the completion of land acquisition process in November 2020 by the Govt. of Gujarat and subsequent handing over to ASI, a large-scale excavation covering an area of approximately 3200 m² was undertaken (Figure 2). Apart from the large-scale horizontal excavation, exposition of a long stretch of 170m fortification wall has also been initiated by the ASI (Figure 3). The effort required to achieve set goals entirely depended upon the number of working days, nature of structures/findings being exposed, weather and protection shed over the excavated area to prevent damage from the rain.

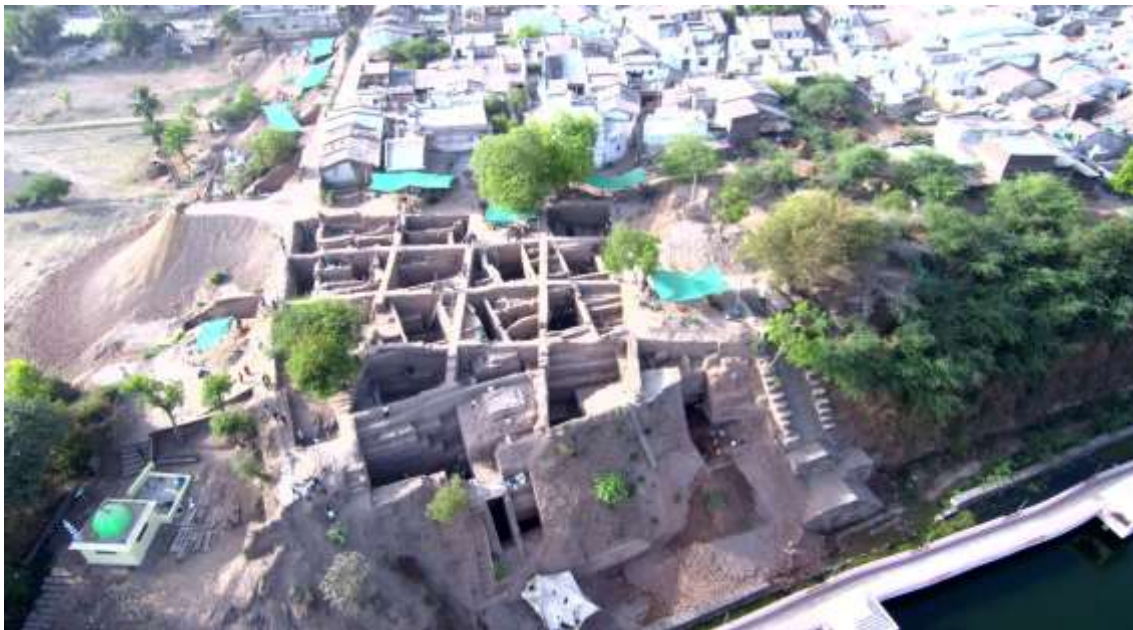
Figure 3: Excavated trenches

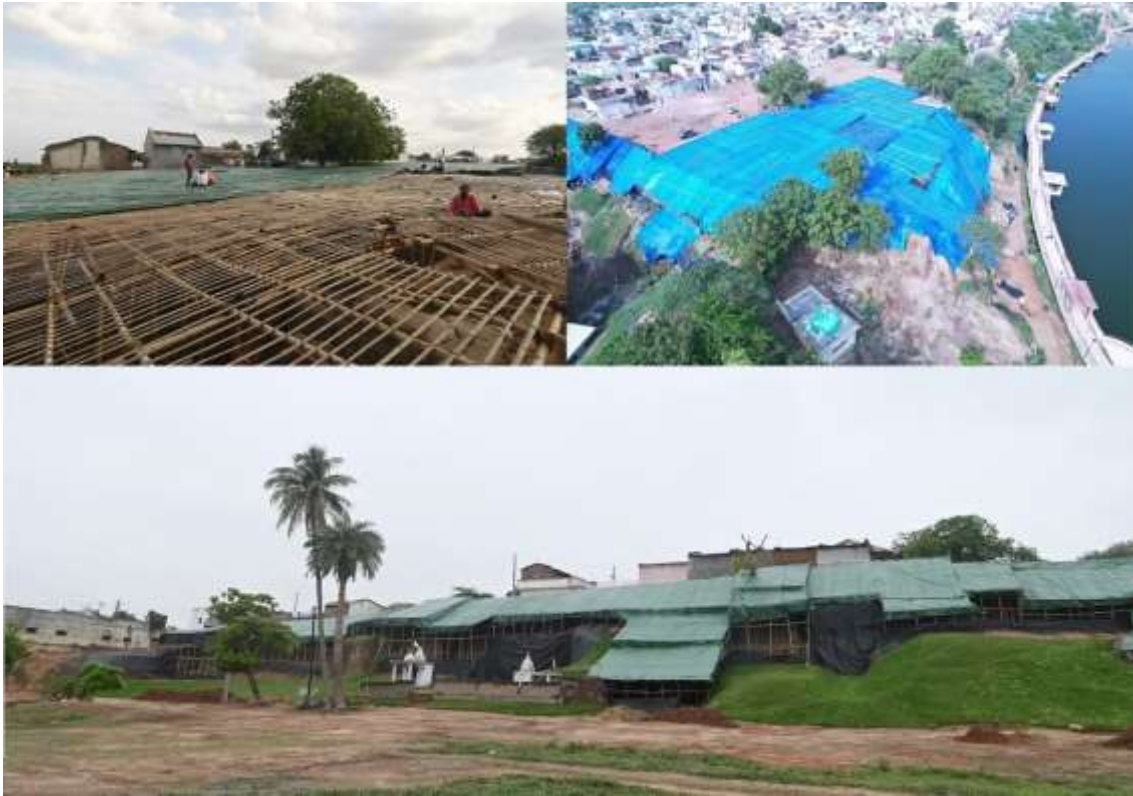
Figure 4: Temporary shed for the protection of excavated remains during monsoon

- Rain remained a problem factor as heavy rains during monsoon coupled with cyclonic or strong winds have led to damage of exposed cuttings.
- To prevent this, the exposed cuttings are required to be protected from the rain by a building a suitably designed shed over it. In the absence of a permanent shed to cover the trenches that had been excavated and the long stretch of the fortification wall, a temporary shed was built (see Figure 4 - Temporary shed for the protection of excavated remains during monsoon).

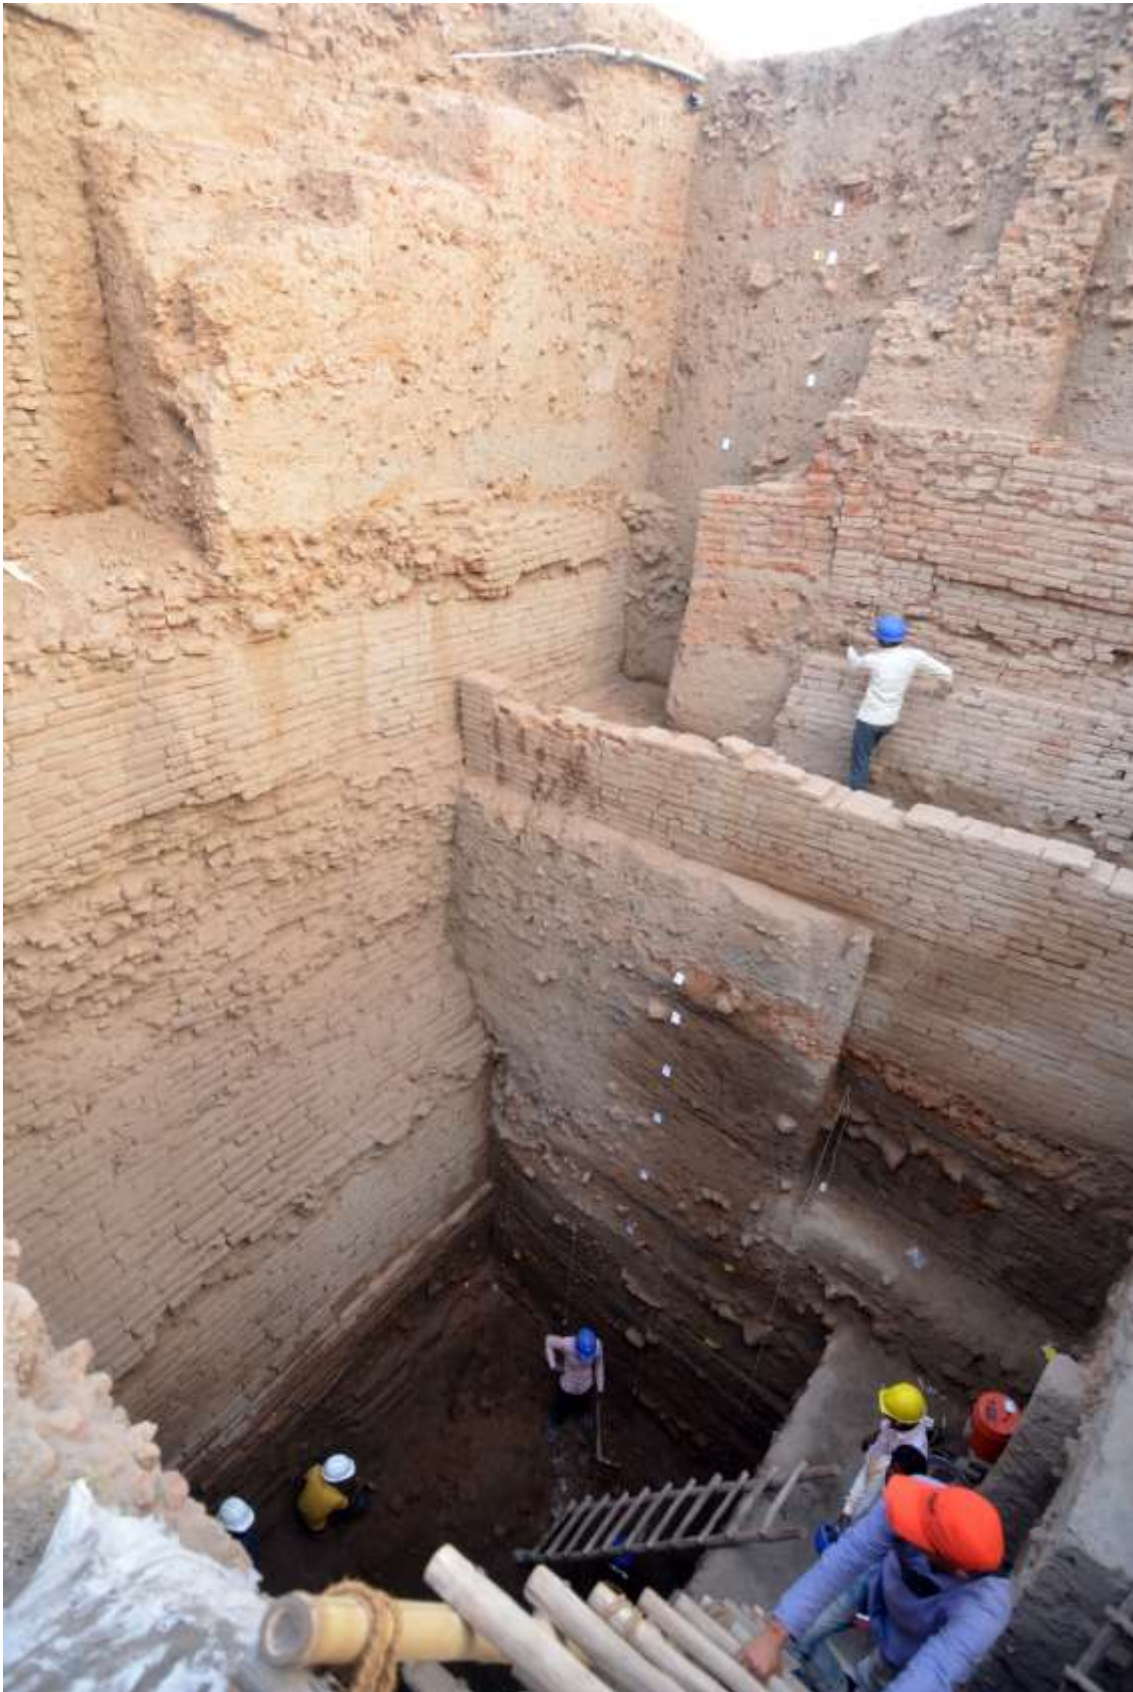
Figure 7: Deep section of walls excavated at Vadnagar during the 2017-18 field season

To facilitate visitors in exploring the ancient settlement that is 2750 years old, an extraordinary design has been designed. This design allows visitors to descend into certain excavated areas and immerse themselves in the experience. One of the main challenges was excavating on a newly acquired 1-acre land, of which two grids had already been excavated up to a depth of 18 meters during the 2017–18 field season. Maintaining its deep section cutting posed a considerable challenge (Figure 7).

1. The excavation was strategically planned in a stepped manner to minimize the depth of the cuttings and prevent any potential collapse of the section.

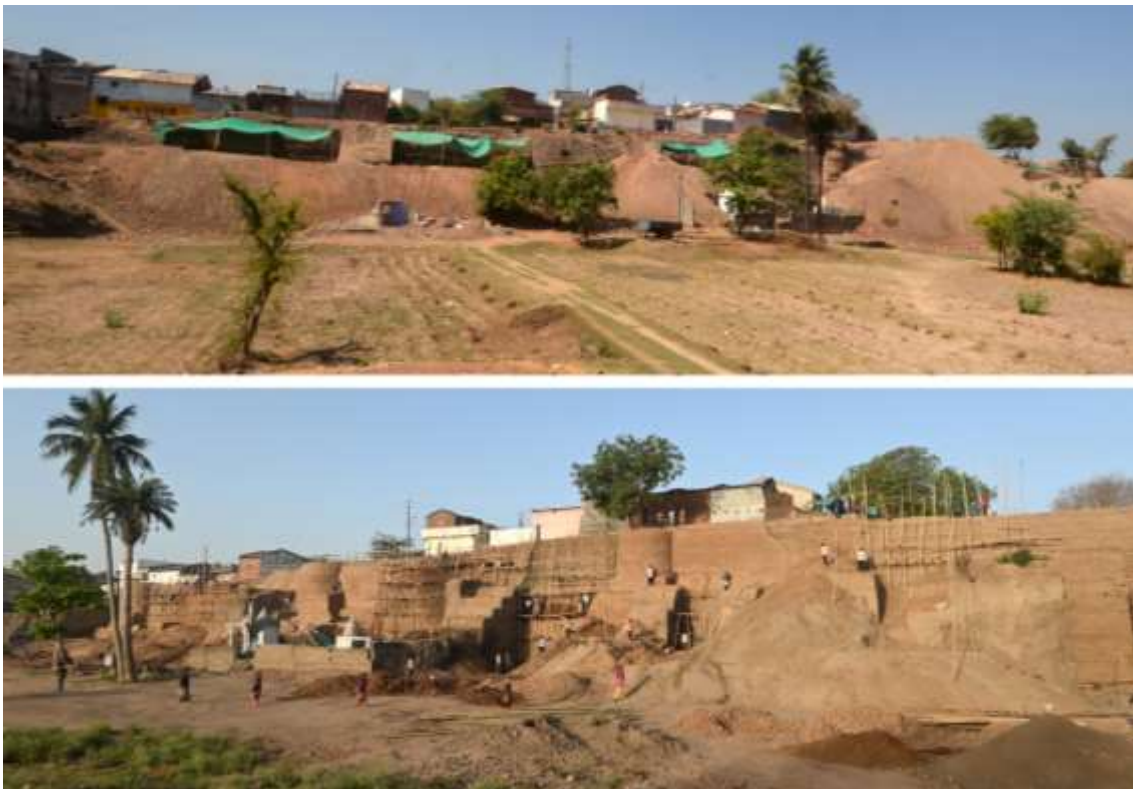
Figure 18: Long stretch of fortification wall - before and after

The untimely rains during the excavation have caused severe damage to the structures and exposed sections. Among them there was a breach of 6m x 3 m to the fortification wall. This breach has been conserved by relaying of ancient bricks and using traditional bonding material. The damage of the remaining exposed structures is also being attended to strengthen its bonding.

The image gallery showcases pictorial records depicting various stages of simultaneous conservation efforts for the unearthed structural remains and different segments of the uncovered fortification wall (Figures 16 – 20).
